SLOPE STABILITY AND GEOLOGY
OF THE BALDWIN HILLS,
LOS ANGELES COUNTY, CALIFORNIA

1982

CALIFORNIA DEPARTMENT OF CONSERVATION
DIVISION OF MINES AND GEOLOGY

SPECIAL REPORT 152

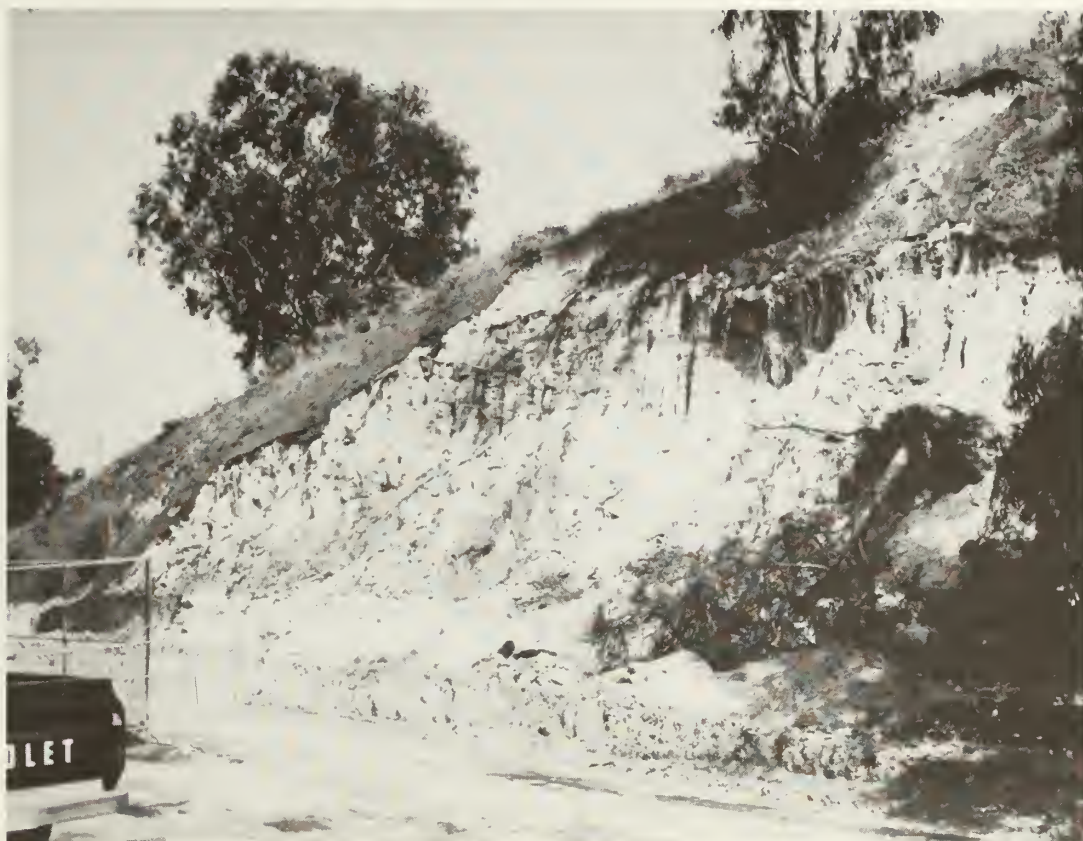
Photo 5. Culver sand (Qc, Plate 1) is exposed in a cut near an oil well in the Inglewood oil field. The sand-silt mixture that has been washed down to the base of the cut has dried firm because it contains a small proportion of clay with which the parent unit is cemented. The original cut was graded at an angle of about 55° and oiled to inhibit erosion. With the washing away of the coating of oil, erosion established the near-vertical profile of badlands topography that this rock tends to develop when exposed to runoff.

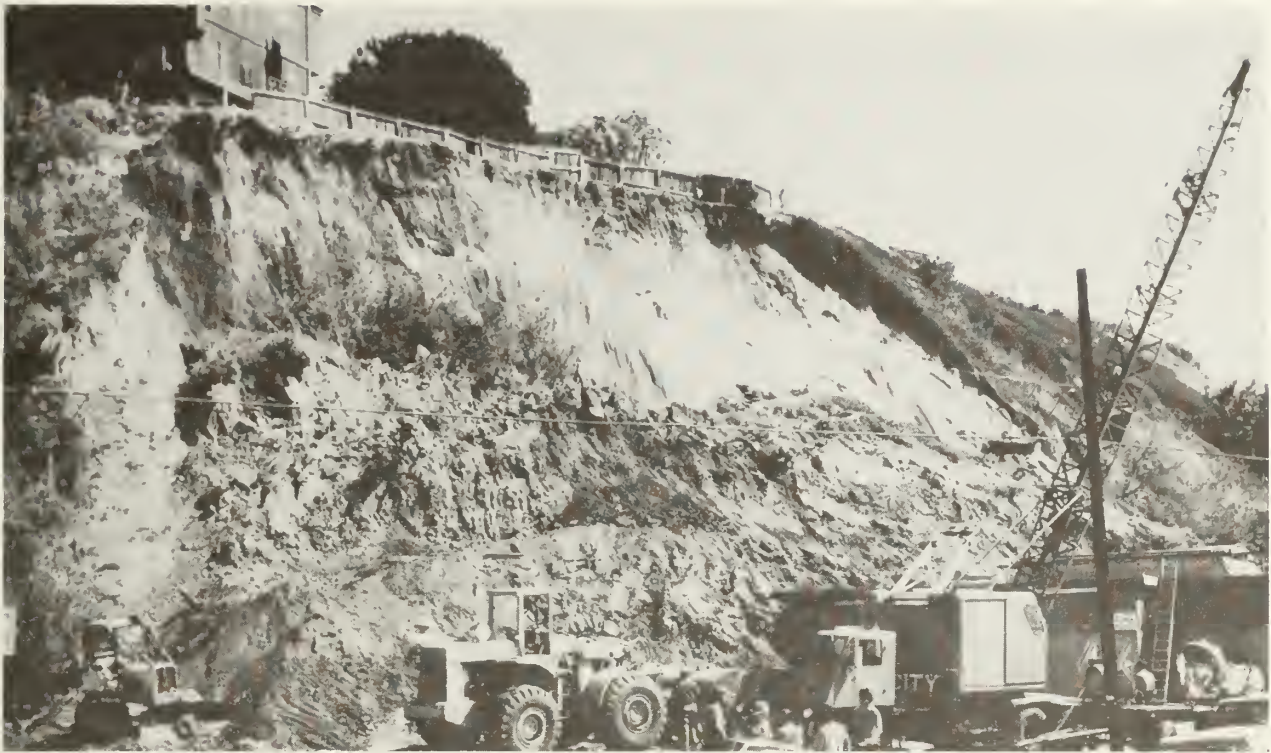
Phata 14. View southwest in 9000 block of Jefferson Boulevard, northwest edge of Baldwin Hills. Landslide shown, which is in a 45° cut slope, occurred initially in 1978 and was partially reactivated early in 1980. The slide mass failed completely in June 1980 during attempts to modify the toe of the slide, damaging the commercial building at the right edge of the phata. (Locality 1, Sub-area 1, Plate 1 and Table 3a). (The damaged commercial building is in the City of Culver City whereas the endangered residential property shown above is in Los Angeles County territory on Hetzler Road.)

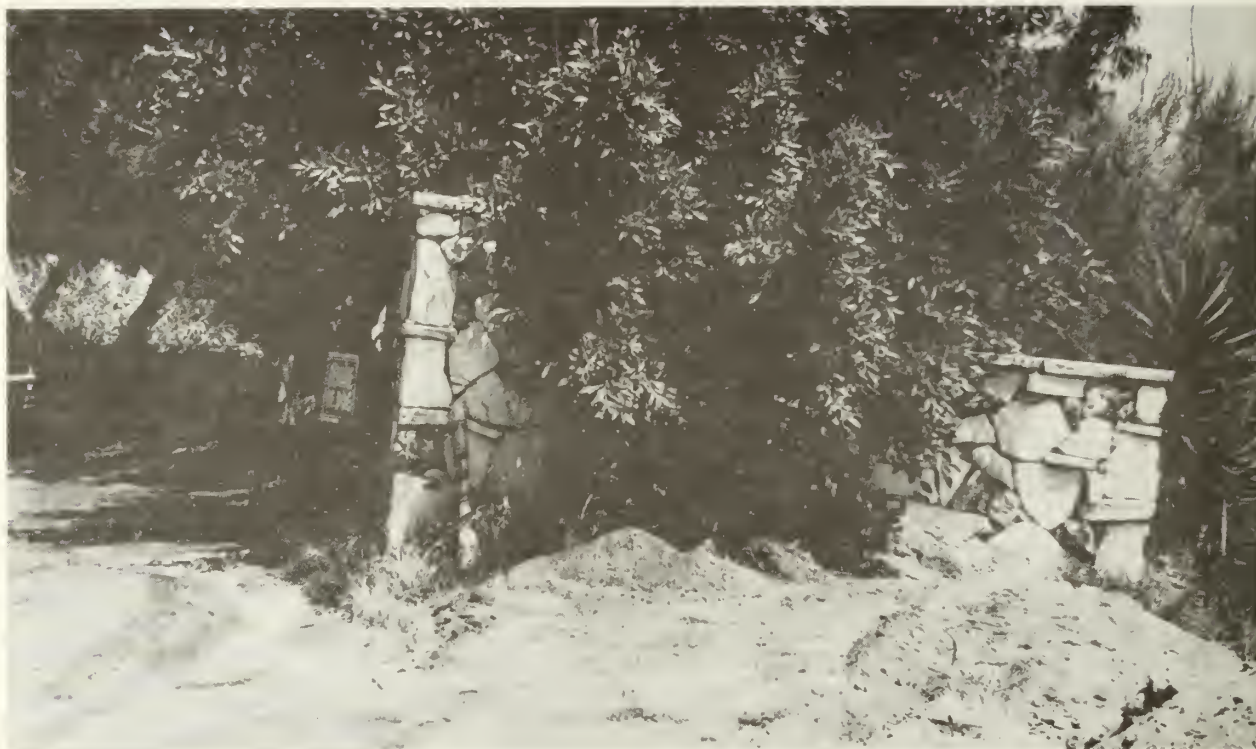
Photo 15. Property on Wrightcrest Drive, Culver City, northwestern Baldwin Hills. Creep and settlement of fill placed during grading for driveway in the early 1950s have caused tilting of the wall and gate shown. (Sub-area 1, Plate 1.)

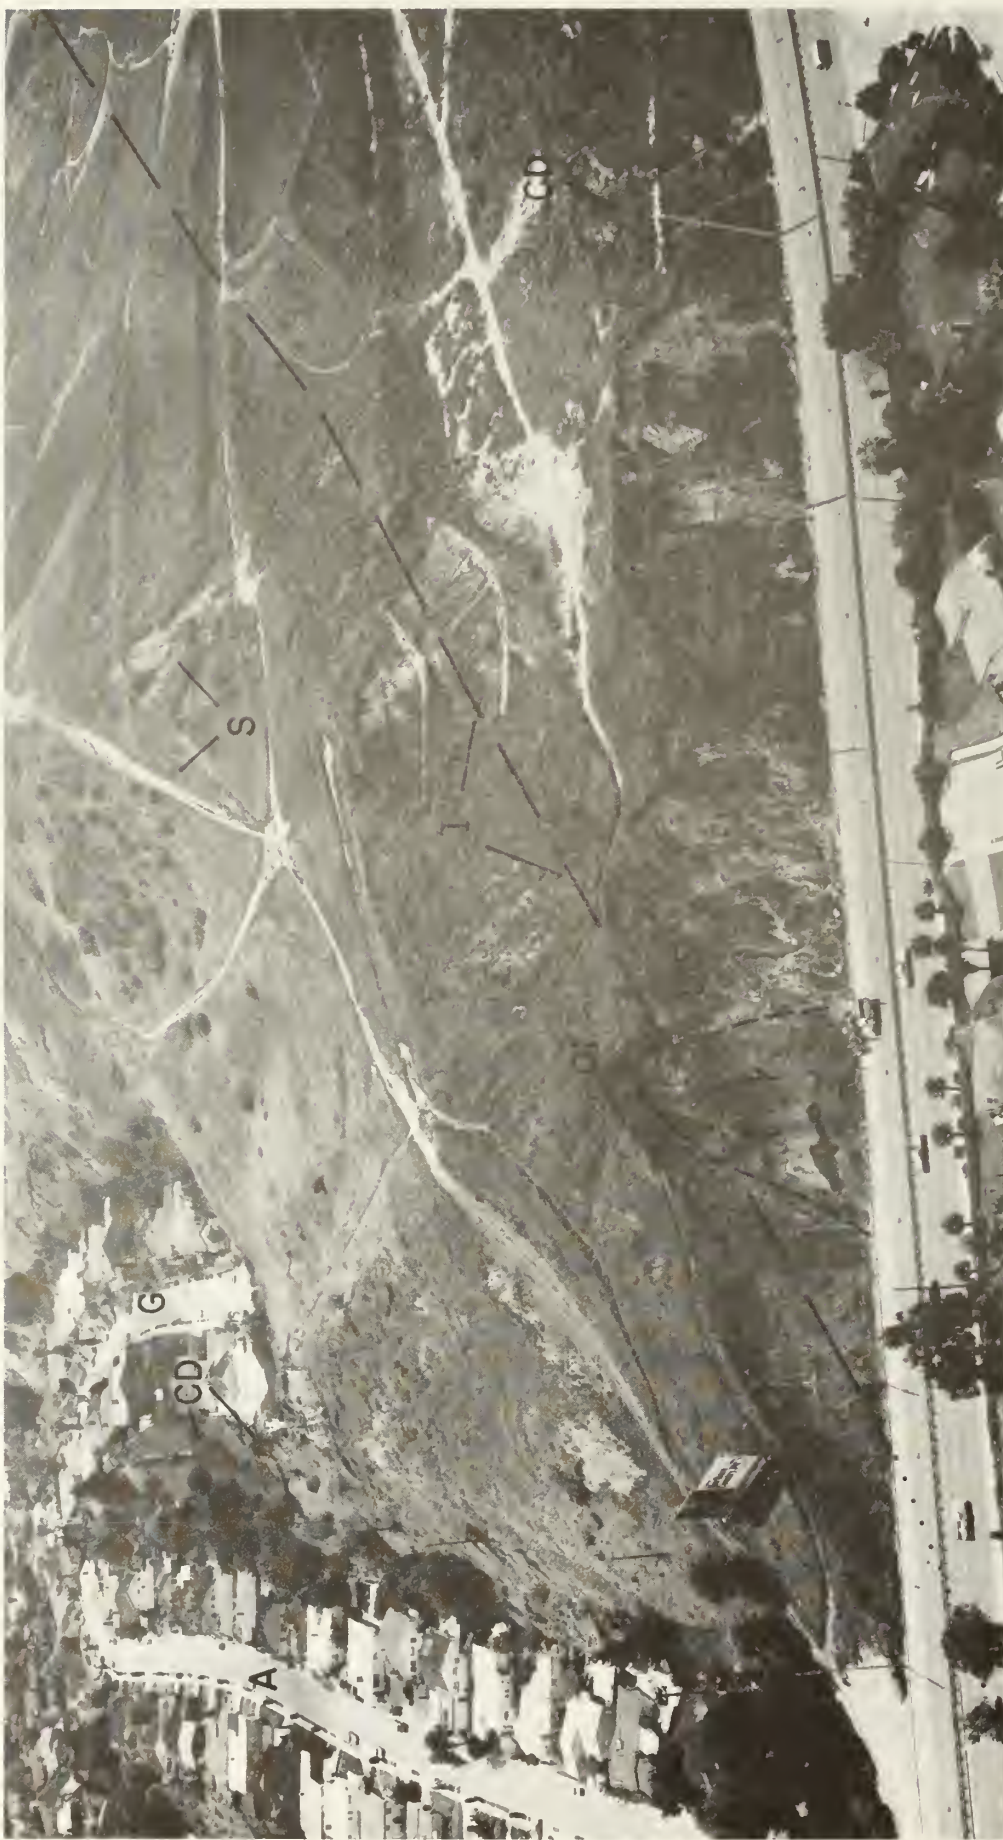
Photo 16. Aerial view to the east-southeast in 1978 across Lo Cienega Boulevard shows landslide in cut that partially blocked traffic flow before slide was cleared. Rock in cut is weakened by crushing and fracturing along Inglewood fault (I), which here separates siltstone and sandstone of Inglewood Formation (Qi) from sand and gravelly sand of Culver sand (Qc). Note the effects of dirt bikes on terrain of center and right of photo, and the two surficial landslides (S). Also note steepness of graded slopes in back of houses on Allodin Street (A) and Glenford Street (G). Observe the unmaintained and clogged bench drains (CD) on slope in back of houses on Allodin Street and along Lo Cienega Boulevard. Slope in back of houses on Glenford Street has no bench drain, even though it was graded after 1952 (see Photo 11). (Localities 9-15, Sub-oreo 2, Table 3b and Locality 90, Sub-oreo 5, Plate 1.) Photograph by John Shadle provided courtesy of the Los Angeles City Department of Building and Safety.

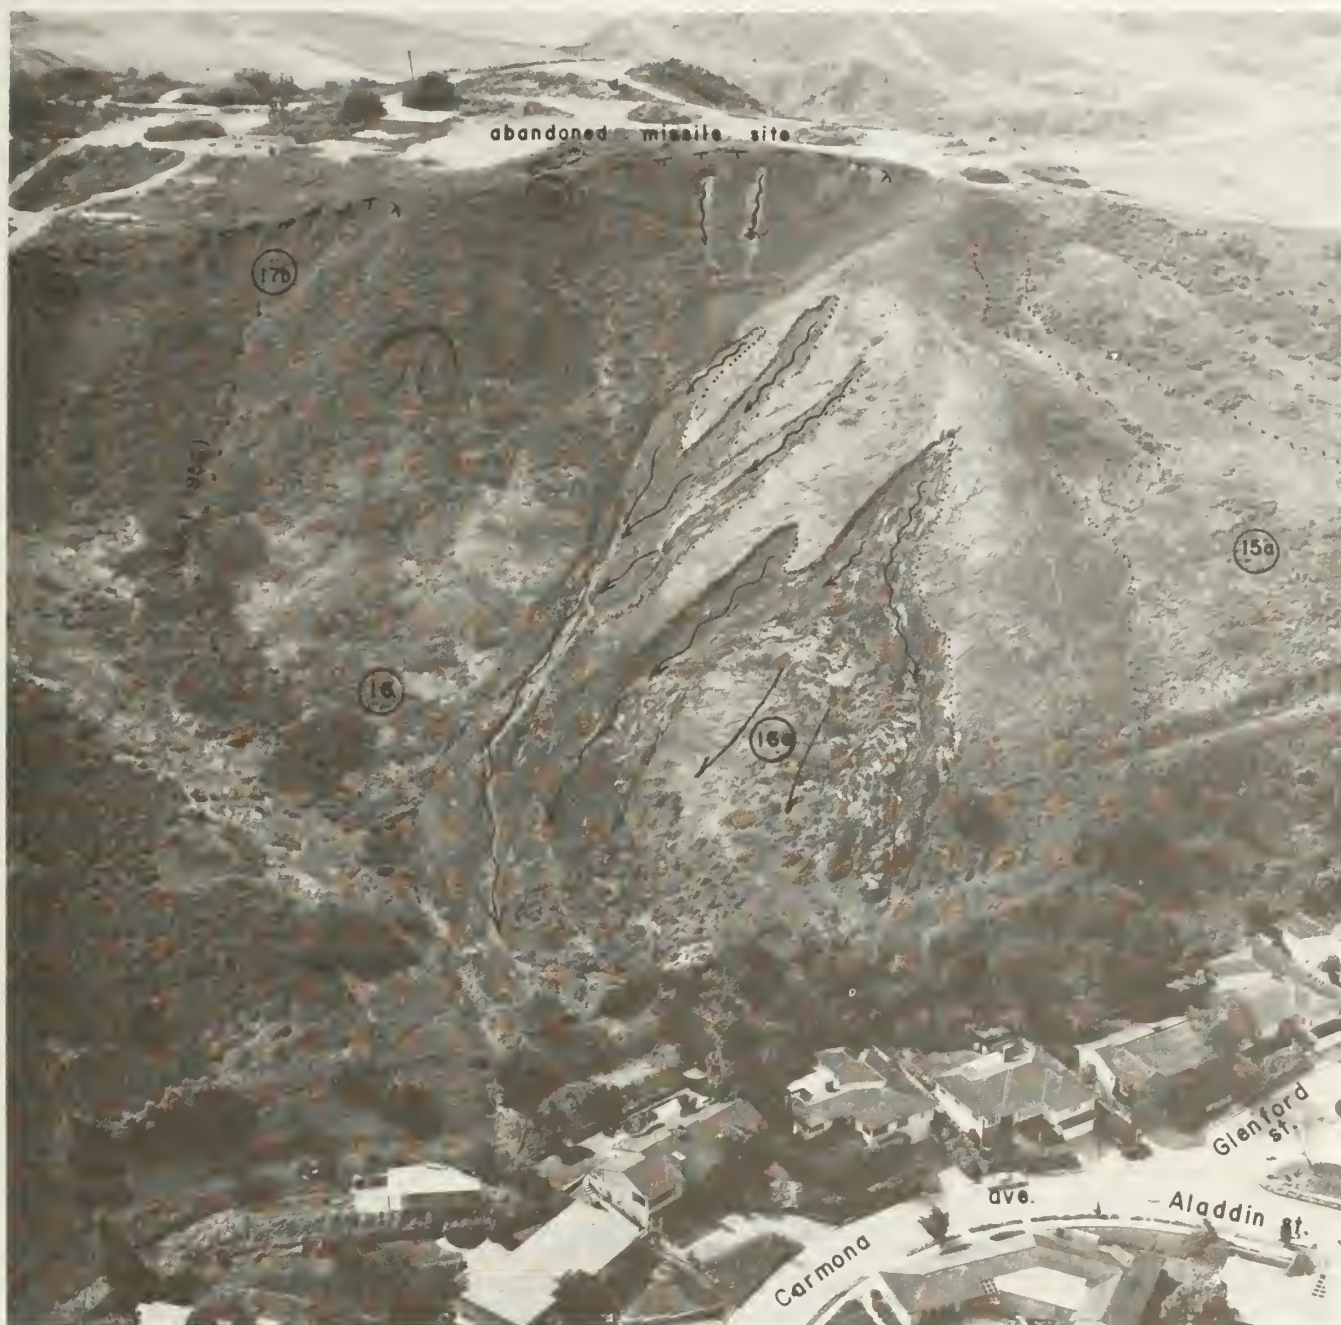
Phata 17. Aerial view southwest shaws slope failures that occurred in 1978 in natural terrain above Carmana Avenue. Wiggly arrows depict surficial debris slides and flaws and erosion; and dual, slightly raunded arraws denate slumping (Locality 16a). Additional slumping and erosion occurred in 1980. Also shawn are the path of a pre-1978 (about 1956) debris flow (heavy dats), areas of thick calluvium (Localities 15a and 16), and arcuate scarps (Localities 17a-c) that have resulted fram progressive, shallow failures. Nate location of closed depression just ta left of Locality 17a which traps water that seeps into the ground. Circled locality numbers and ather slope failure features are described in Table 3b and depicted in red an Plate 1. See also discussions of Slope Segments D and F, Sub-area 2. Photograph by John Shadle provided courtesy of the Los Angeles City Department of Building and Safety.

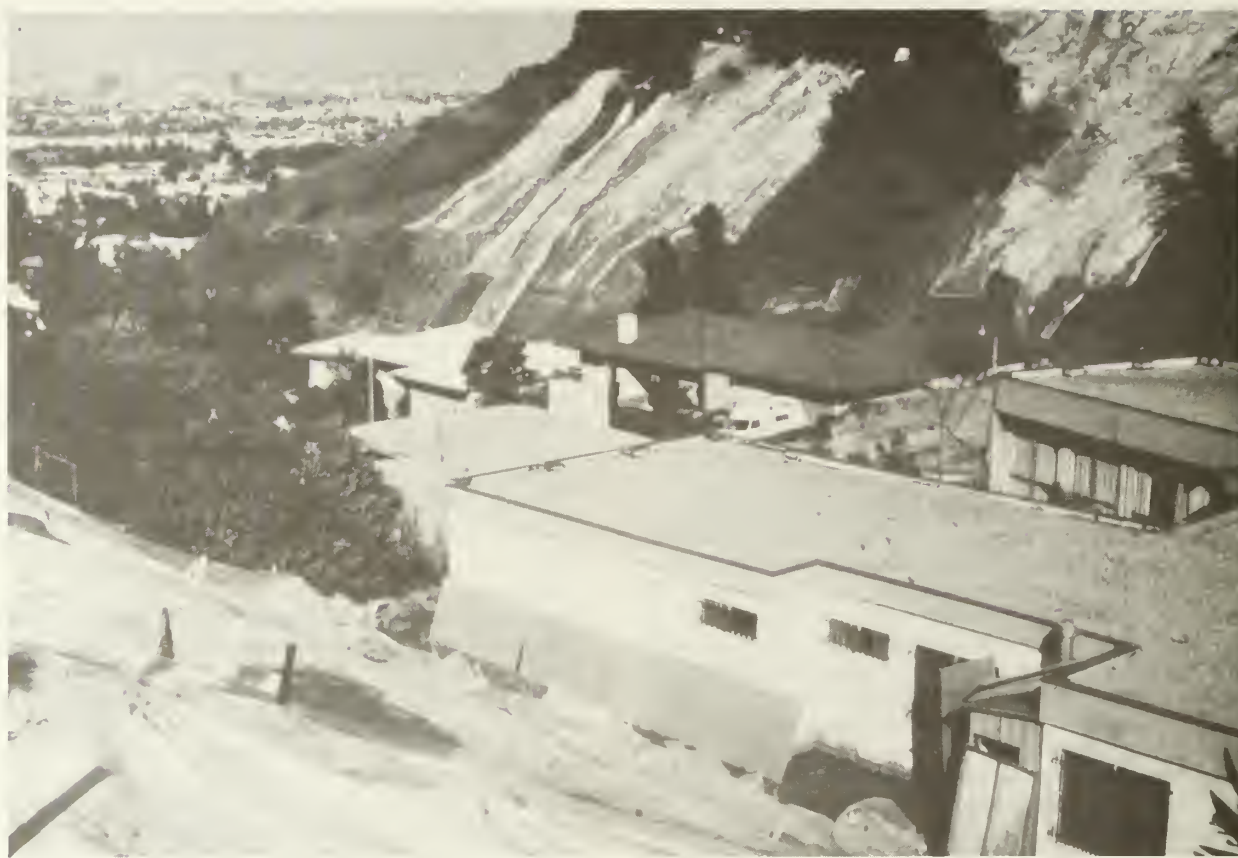
Photo 18. View north-northeast across Claverdale Avenue shows steep slopes that failed during the rains of March 4-5, 1978 (slopes were covered with plastic sheets after the damaging rains for protection against possible subsequent rains). Slopes yielded relatively shallow debris slides and flaws, and soil slips from cut and fill slopes. Bedrock is very gently dipping silty sand (Qi, Plate 1). Serious damage also was caused to back edges of properties on Veranica Street above far slope at upper right. (Localities 32-37, Sub-area 2, Table 3b and Plate 1.)

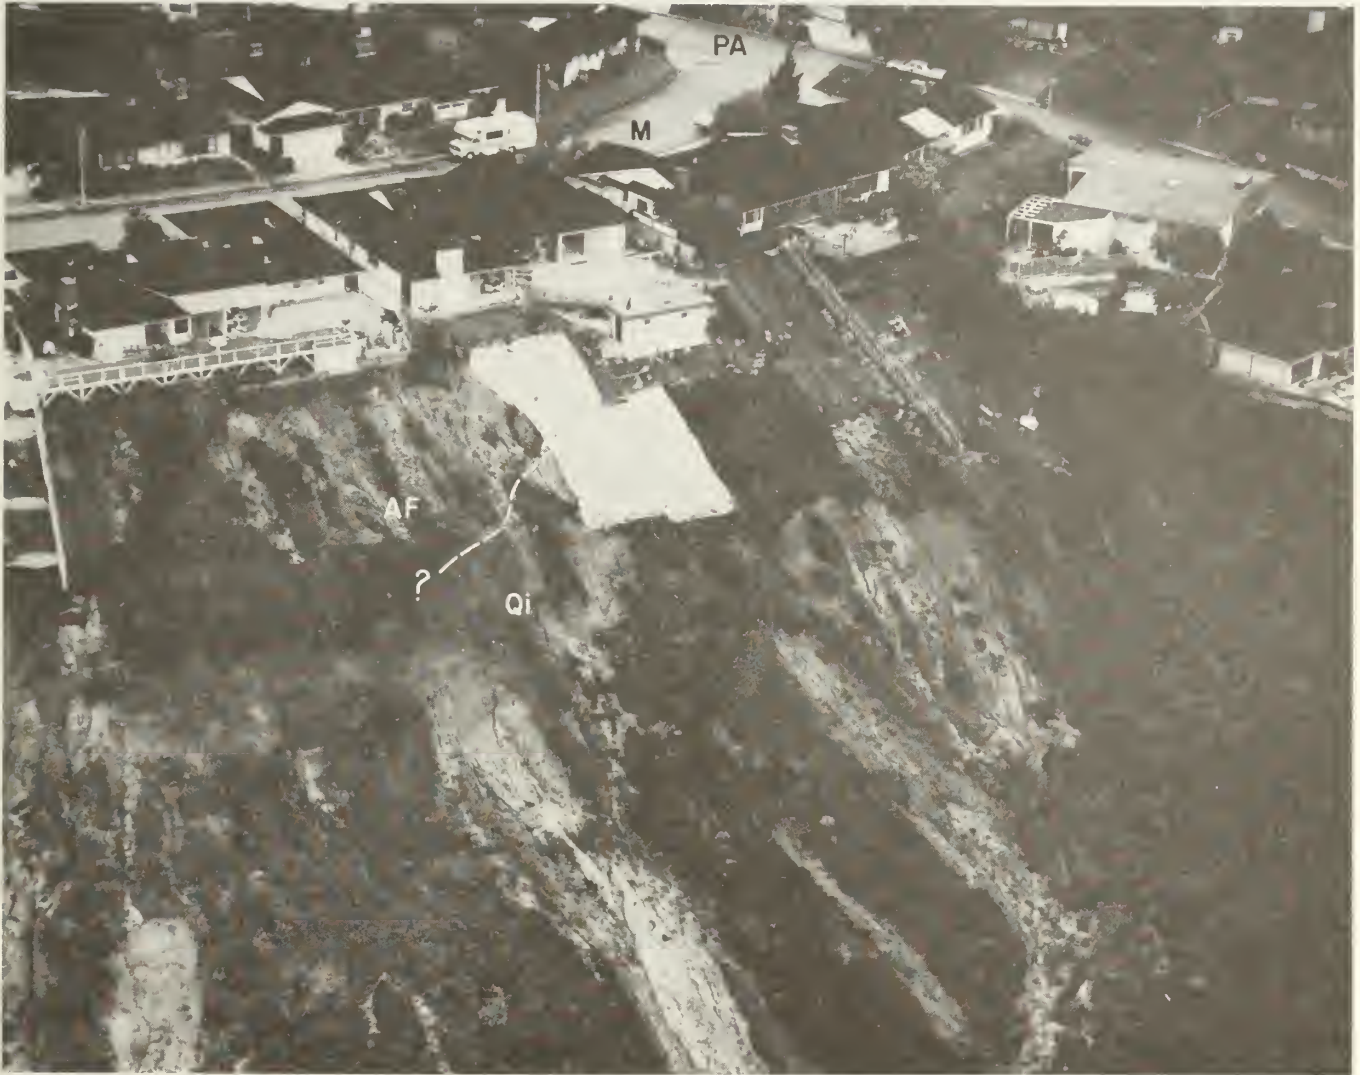
Photo 19. Closeup aerial view northwest in 1978 shows intersection of Punto Alto Drive (PA) and Montova Drive (M) and damage to steep slope bordering houses on Montova Drive caused by shallow debris slides and flows, and minor erosion. View shows that small building in back of swimming pool on property at left-center of photograph has been slightly undermined by the sliding. Note edge of concrete retaining structure at left edge of photo that protects property mostly out of view. Contact shows part of the boundary between gently dipping Inglewood Formation (Qi) and overlying artificial fill (af) employed during grading for tract. Photograph by John Shadle provided courtesy of the Los Angeles City Department of Building and Safety.

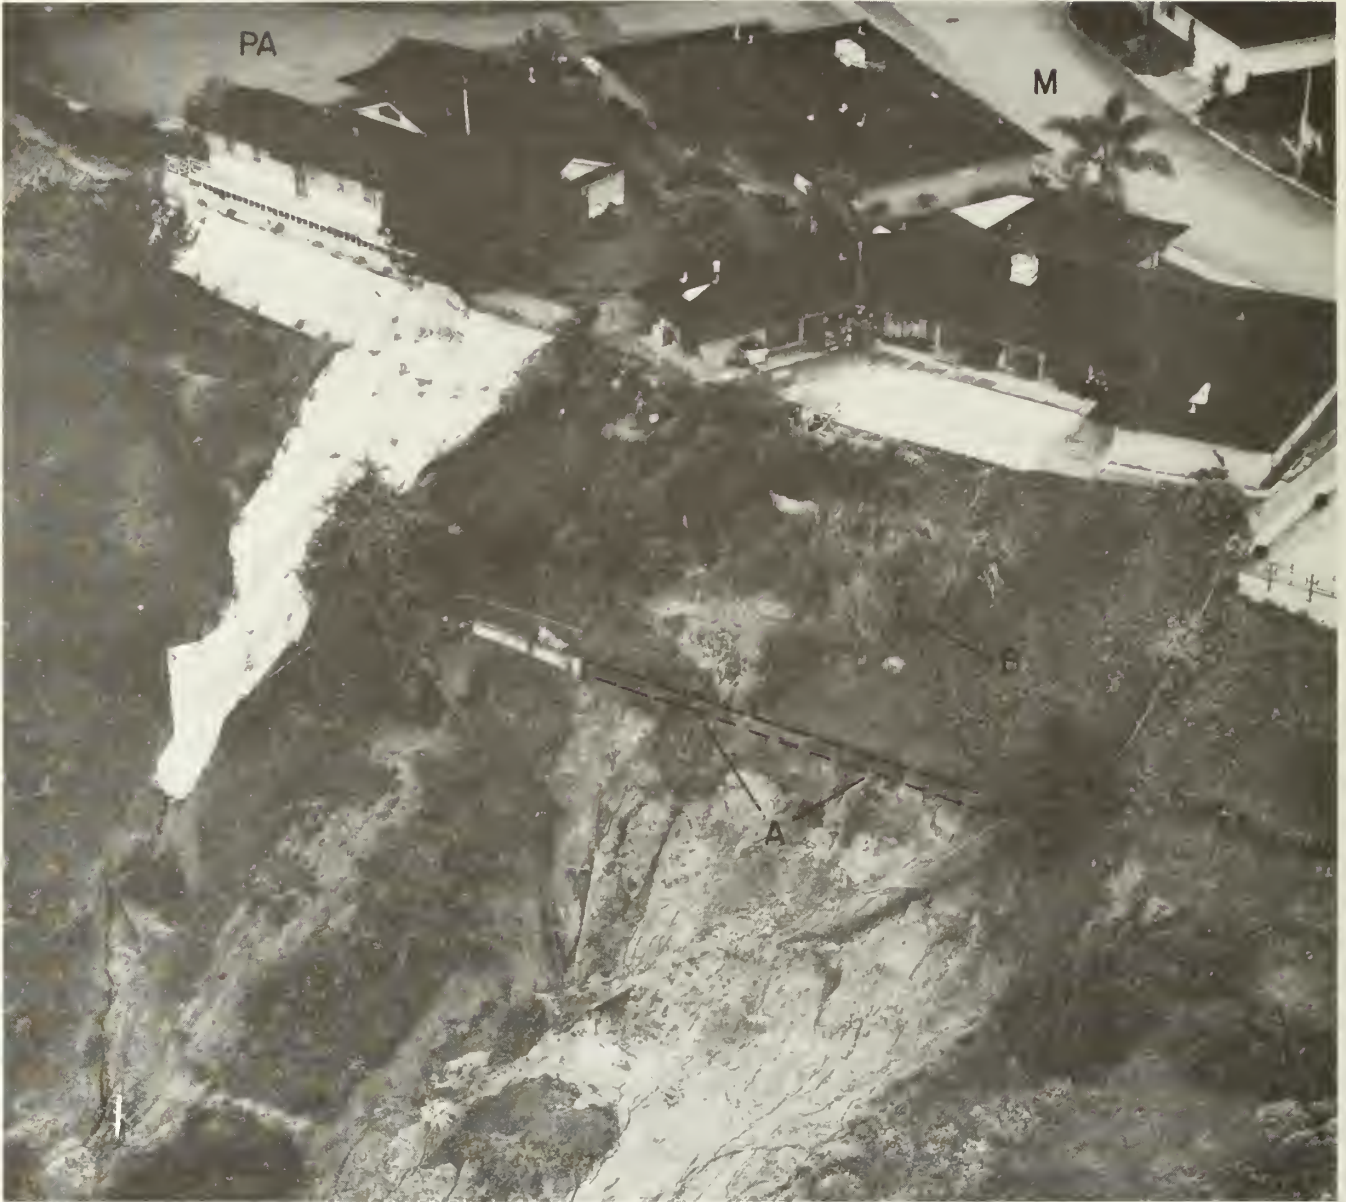
Photo 20. Closeup aerial view to the northwest in 1978 shows slope damaged by debris flows and erosion just south of intersection of Punto Alto Drive (PA) and Montovo Drive (M) (Locality 50, Sub-area 2, Plate 1 and Table 3b). (Site of Baldwin Hills Reservoir lies to left of the photo scene.) Note contributing and possibly contributing factors to slope failure: A, fence and anchoring device that collapsed; and B, remnants of lush vegetation that suggests overwatering or seepage of water into slope, possibly from swimming pool leakage. Photograph by John Shadle provided courtesy of the Los Angeles City Department of Building and Safety.

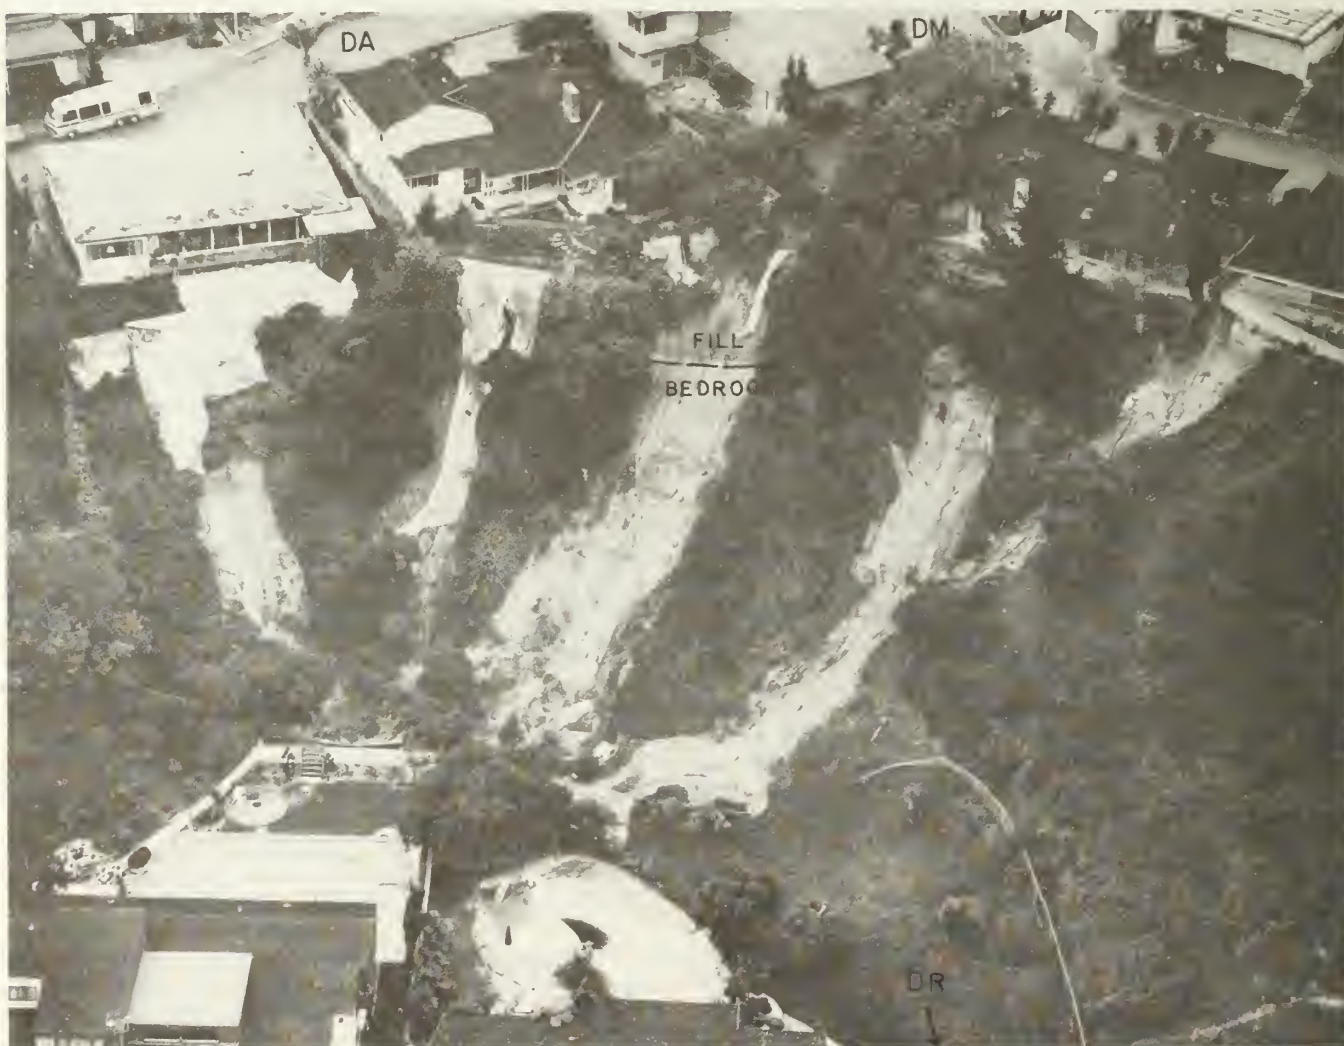
Photo 21. Closeup aerial view south in 1978 shows five distinct, very shallow debris flows that caused damage to slope between Don Alegre Place (DA) and Don Milagro Drive (DM) at top and two properties on Don Rudolfo Place (DR) at the bottom. Slight undermining of patios and walls occurred at the top of the slope and damage to a fence and other backyard improvements occurred at the base. Damage was small because volume of debris was small; it consisted only of a veneer of vegetation and weakly developed soil overlying weathered fill and bedrock. (Localities 58 and 59, Sub-figure 3, Plate 1 and Table 3c.) Photograph by John Shadle provided courtesy of the Los Angeles City Department of Building and Safety.

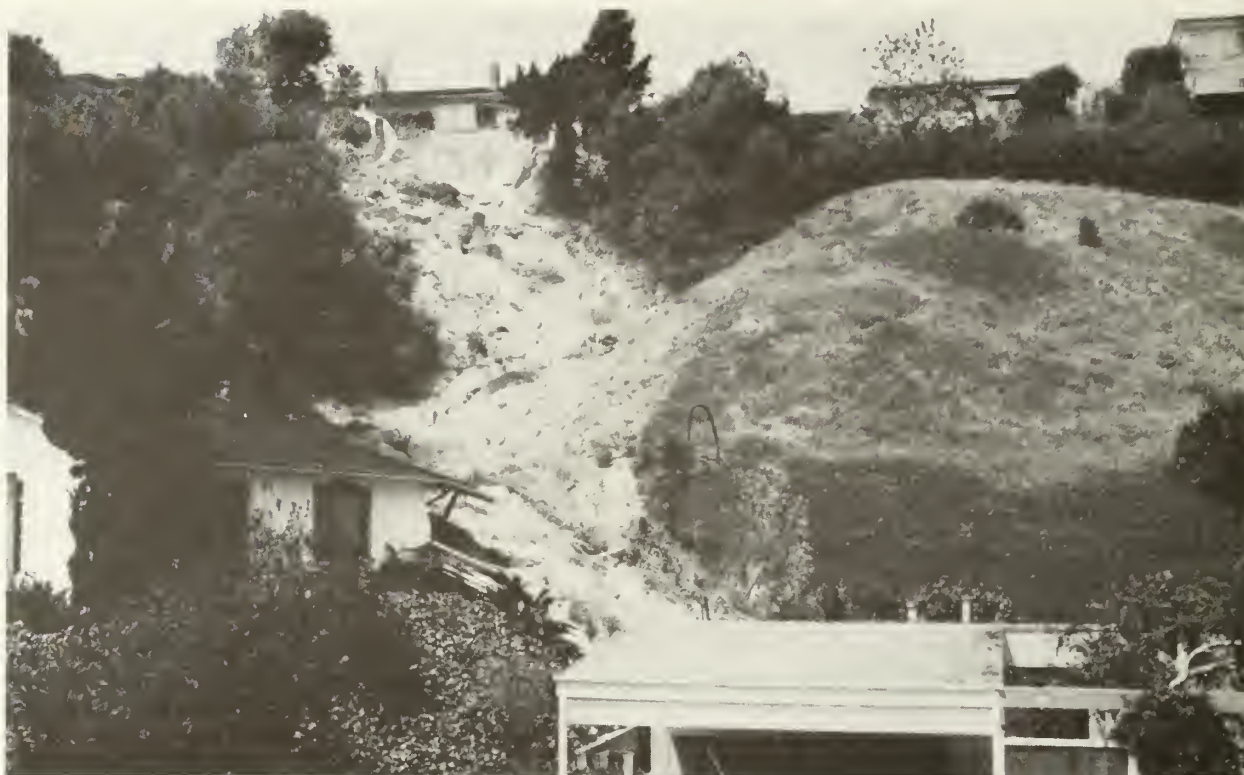
Phata 22. View west shows path of debris flow that originated in fill that was placed during development for backyard of residence on Don Alegre Place shown at top of slope. The an-rushing watery debris of the flaw seriously damaged the house to the left and caused lesser damage to the house on the right at the battam of the slope on the west side of Hillcrest Drive. The flaw occurred an February 16, 1980; the phata was taken in April 1980. By February 1981, the seriously damaged house had been razed and a new house was being constructured. (Locality 61, Sub-area 3, Plate 1 and Table 3c.)

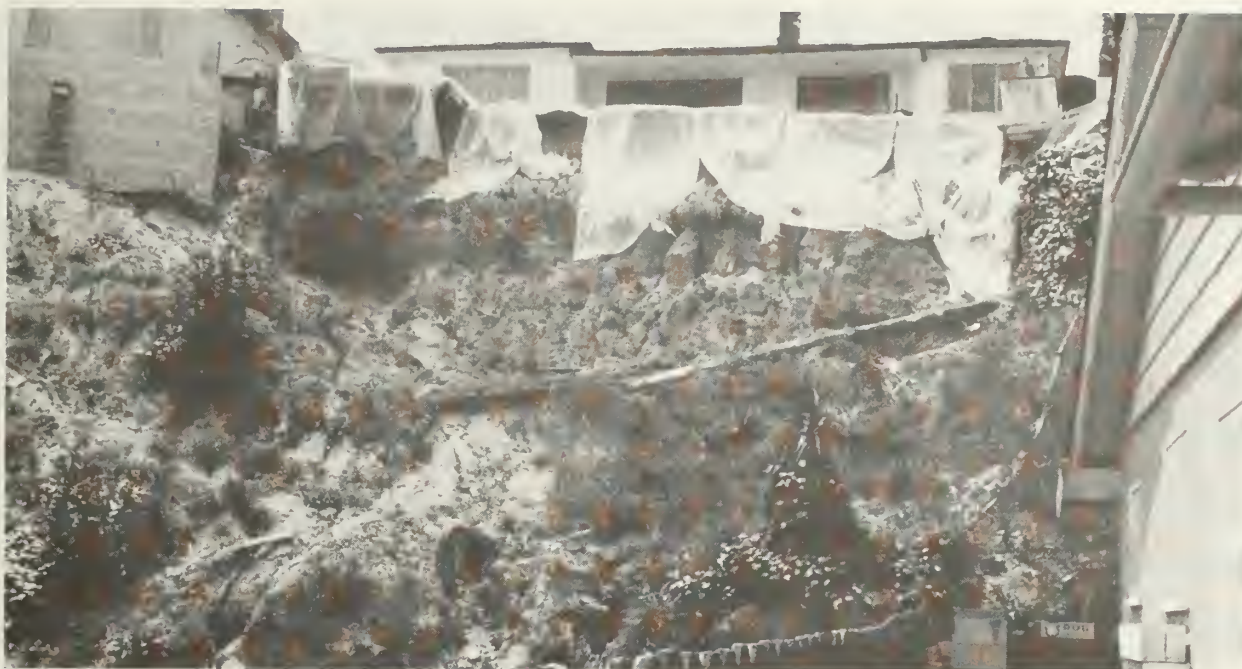
Phata 23. View south shows shallow slump and erosion which occurred during the rains of 1978, damaging backyard of house shown located on the north side of Dan Mariana Drive. Failure originated in fill. Note the repaired slope and the newly constructed retaining wall at the left edge of the photo. Photo was taken in April 1980. (Locality 68, Sub-area 3, Plate 1 and Table 3c.)

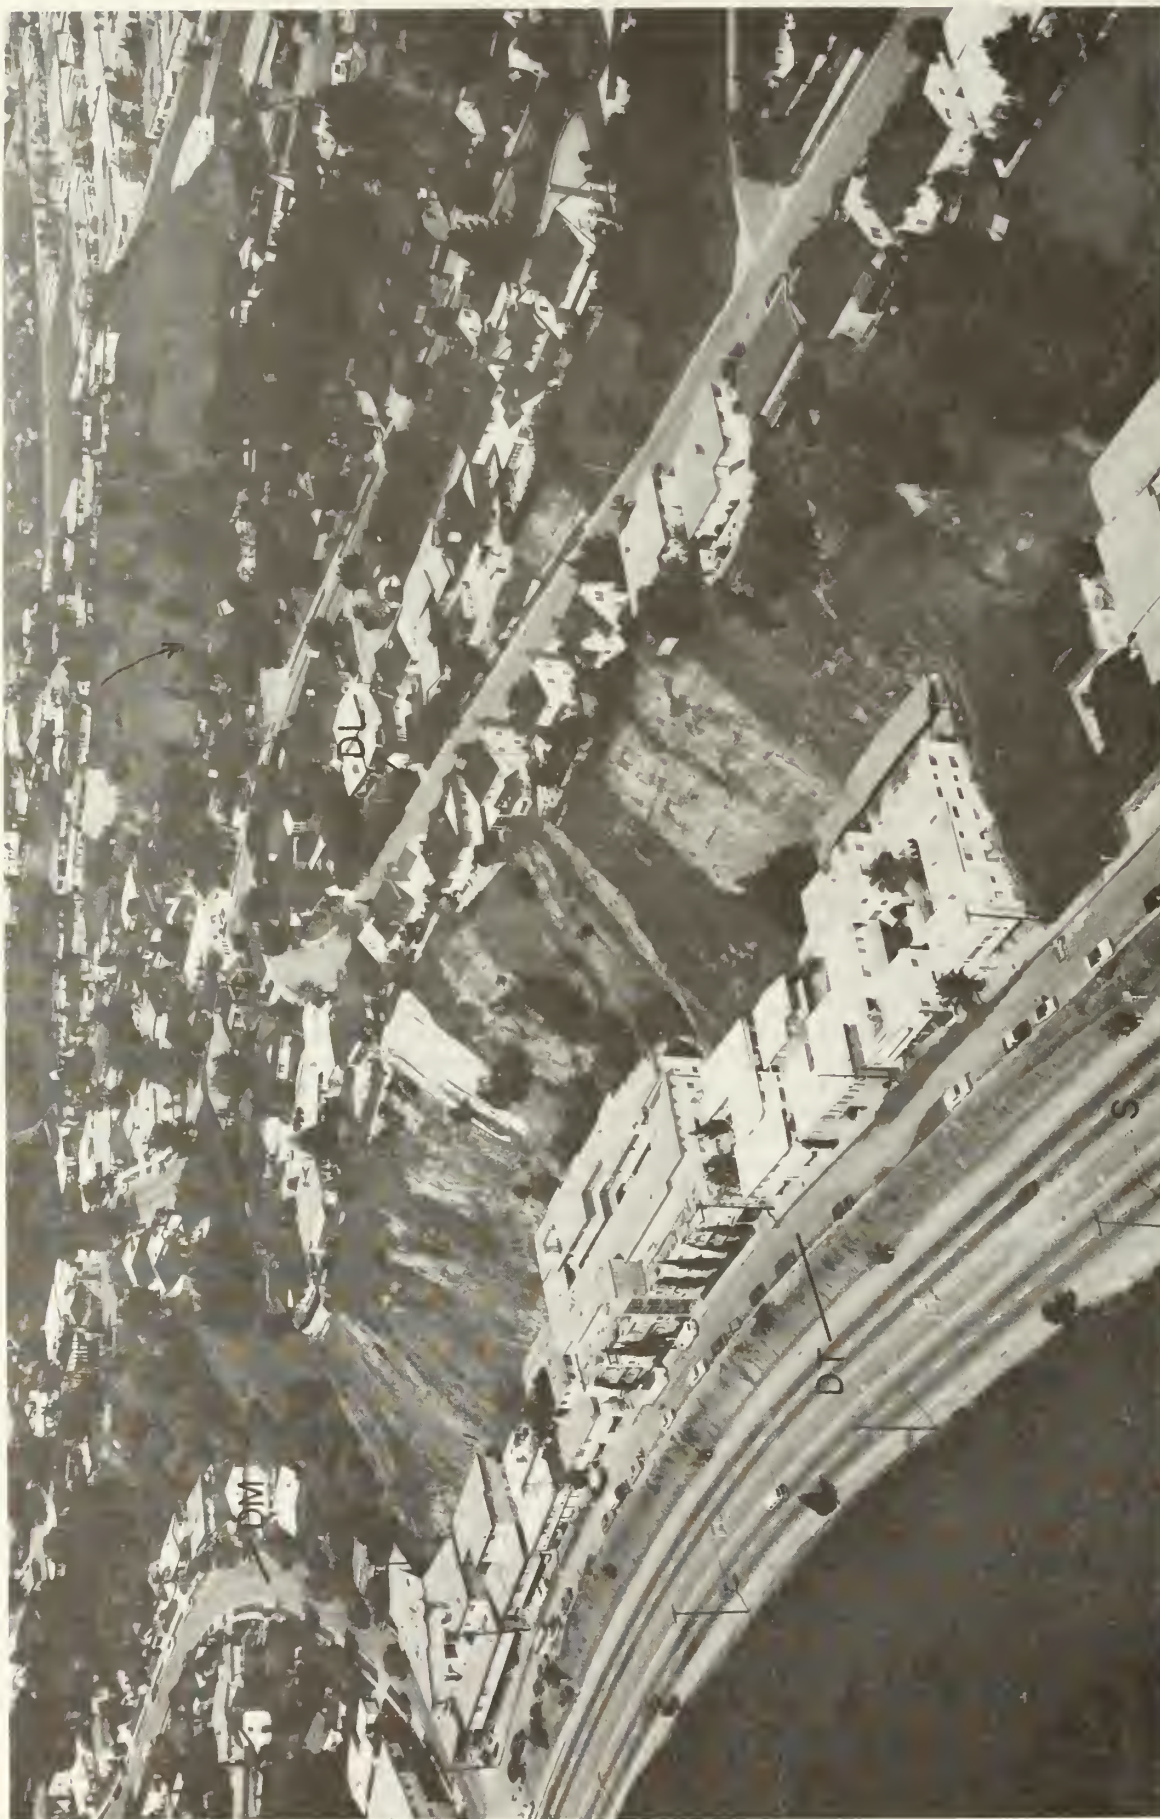
Photo 24. Aerial view to the northwest across Stocker Street (S) in 1978 shows slopes bored by surficial debris slides and flows and by erosion during the rains of March 4-5, 1978. Apartment buildings damaged at base of slope are on Don Tomoso Drive (DT), and single family residences of top of slope are on Don Luis Drive (DL). Street at left of photograph is Don Miguel Drive (DM). (Localities 73 and 74, Sub-area 3, Plate 1 and Table 3c.) (Arrow in right background marks path of debris flow on northwest side of Hillcrest Drive in 1980 [Locality 61; Photo 22].) Photograph by John Shadle provided courtesy of the Los Angeles City Department of Building and Safety.

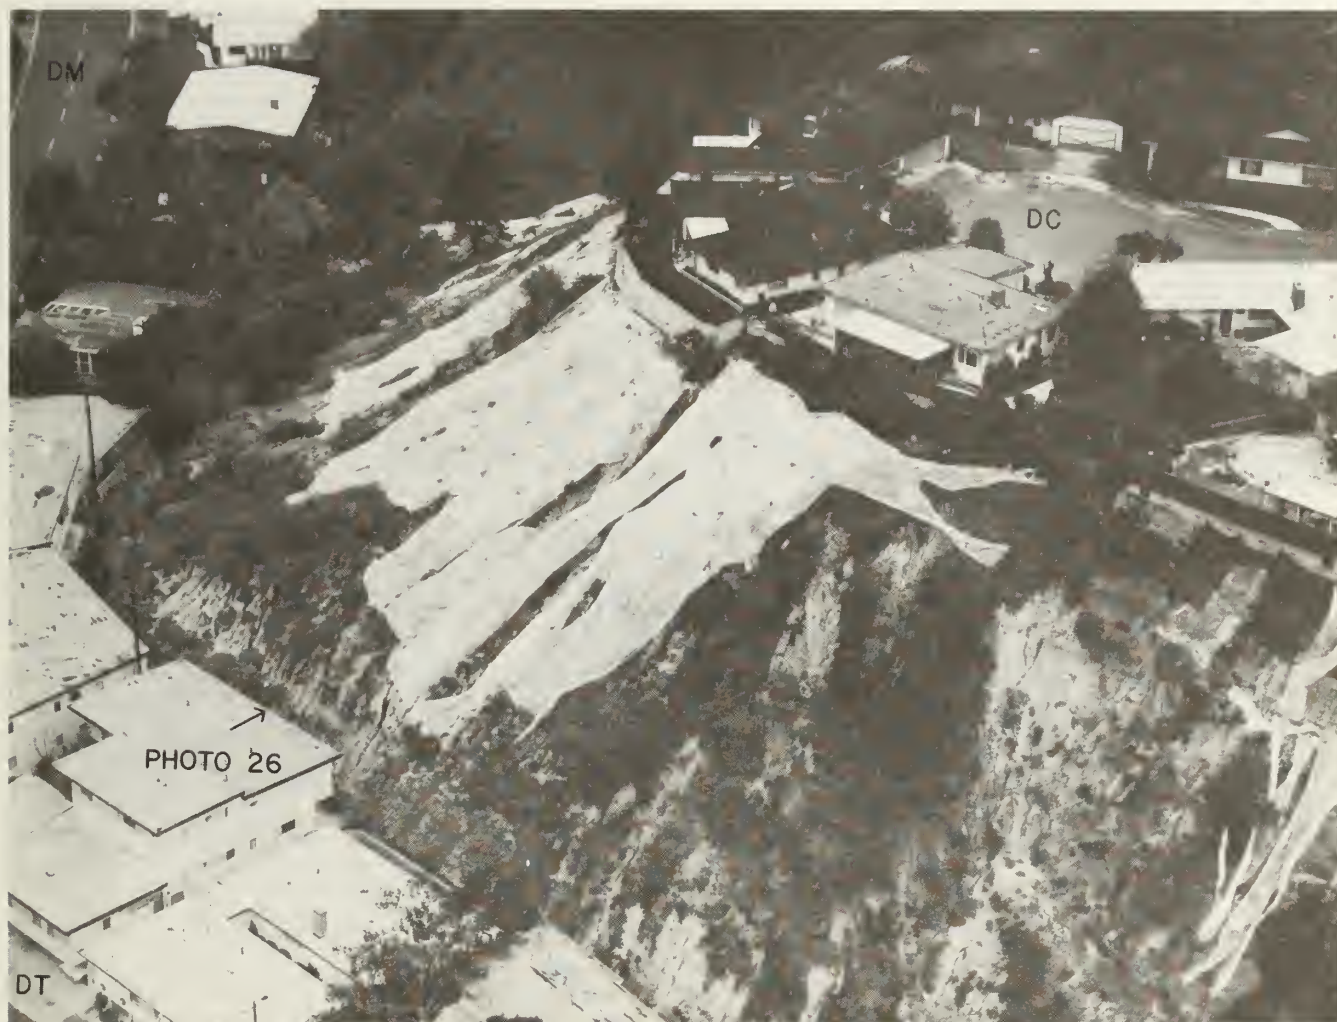
Photo 25. Closeup aerial view to the northwest shows the effects of the 1978 rains on the steep slope north of the intersection of Don Miguel Drive (DM) and Don Tomoso Drive (DT). Shallow debris slides and flows, and erosion caused damage to apartment buildings at base of slope on Don Tomoso Drive (Photo 26) and endangered backyards of single family residences on Don Coto Place (DC). (Localities 72 and 73, Sub-area 3, Plate 1 and Table 3c.) Photograph by John Shadle provided courtesy of the Los Angeles City Department of Building and Safety.

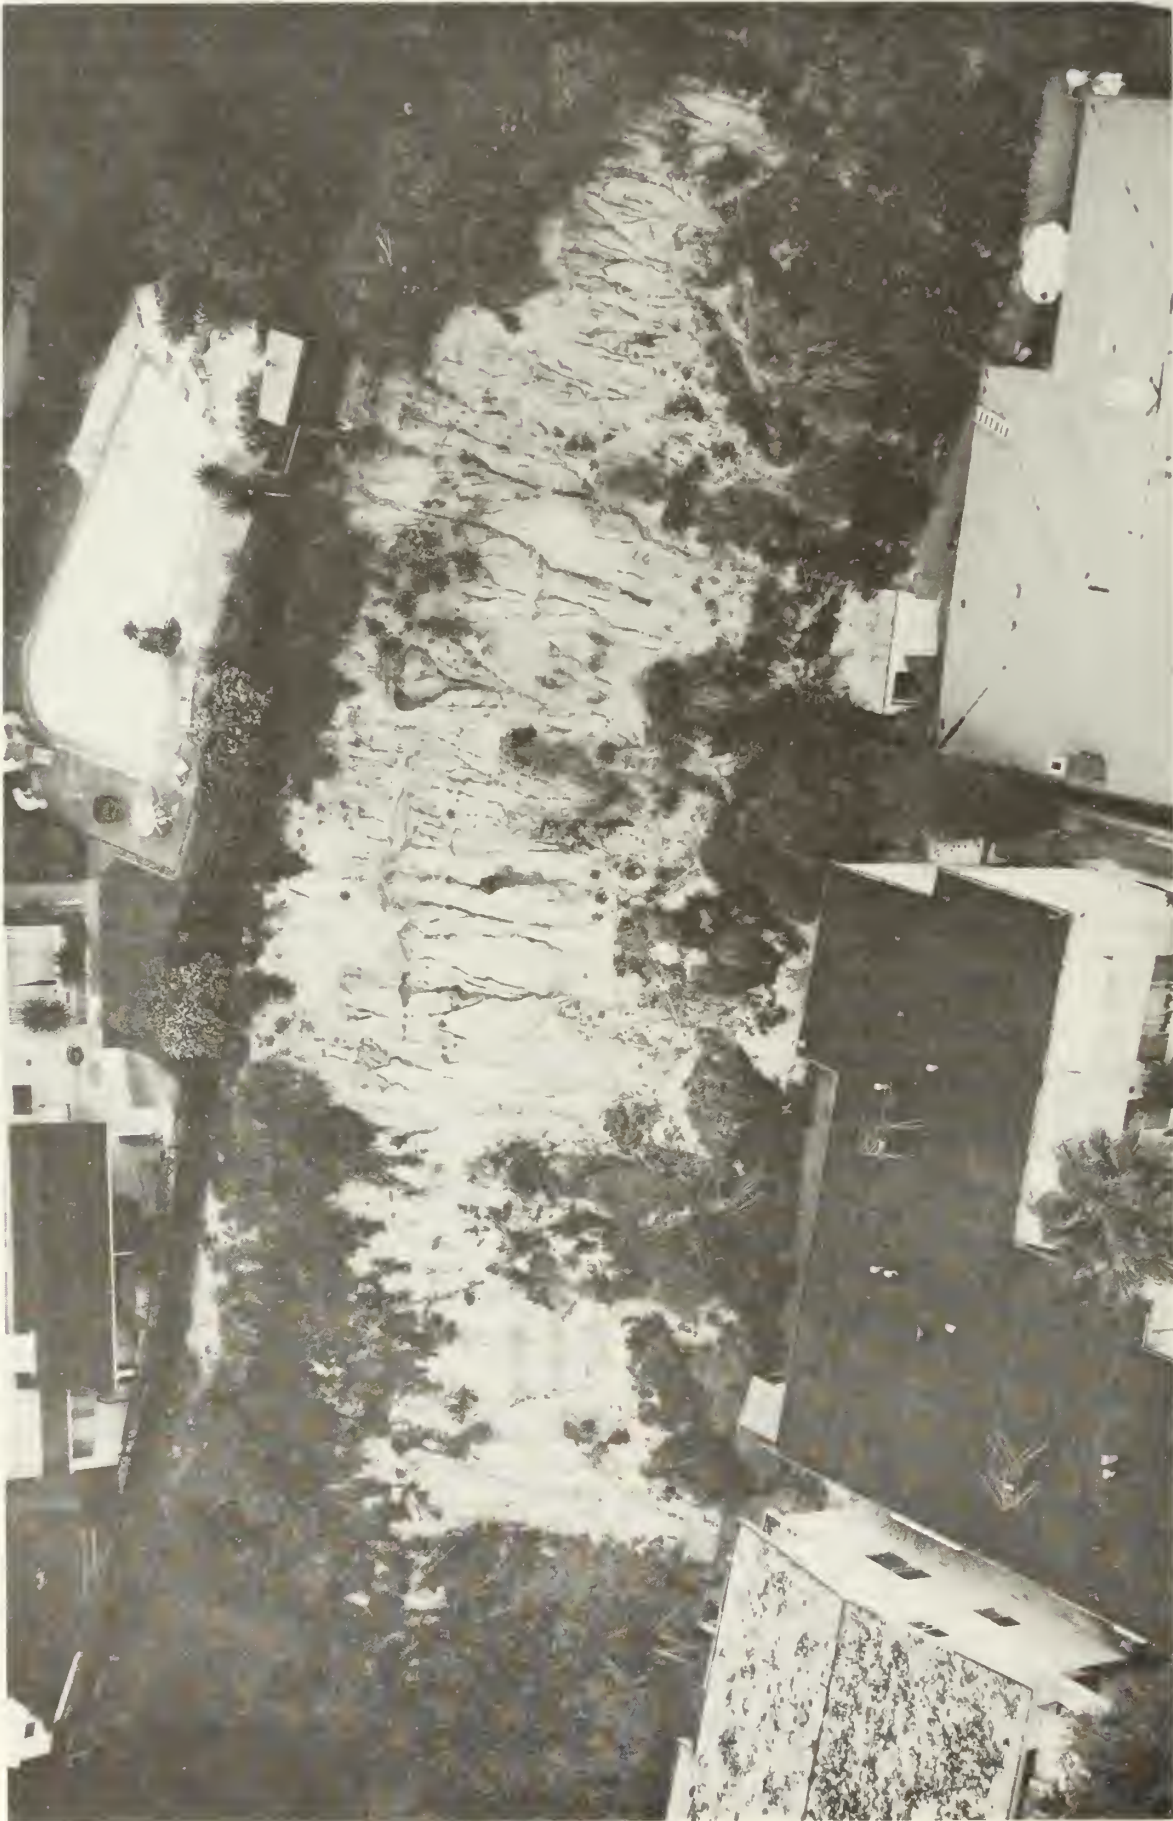
Photo 27. Closeup aerial view in 1978 showing effects of debris slides and erosion on slope along Stacker Street. Backyards far single family residences at top of slope are endangered by the cutting-back effects of the erosion. Apartment buildings of the base of the slope will be endangered until a wall is constructed to prevent debris from flowing downward into the buildings. (Locality 77, Sub-area 3, Plate 1 and Table 3c.) Photograph by John Shadle provided courtesy of the Los Angeles City Department of Building and Safety.

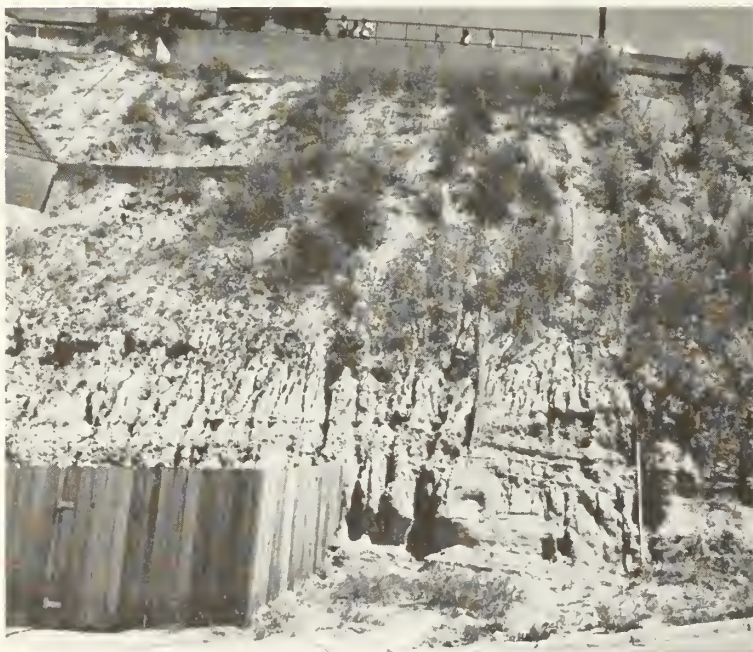
Photo 29. View east shows south edge of house in Photo 28 after the adjoining slope was cleaned off and repaired after the 1978 rains. Note that erosion caused by the 1980 rains cut well into the bared bedrock slope. View also shows an apparent angular discordance between beds of the Baldwin Hills sandy gravel (Qb, Plate 1) (parallel to and above the fence top) and underlying beds of the Culver sand (Qc).
